Termite Inspection Report

Property Address: 151 E Spur Ave Gilbert AZ 85296

Arizona Department of Agriculture Pest Management Division WOOD DESTROYING INSECT INSPECTION REPORT

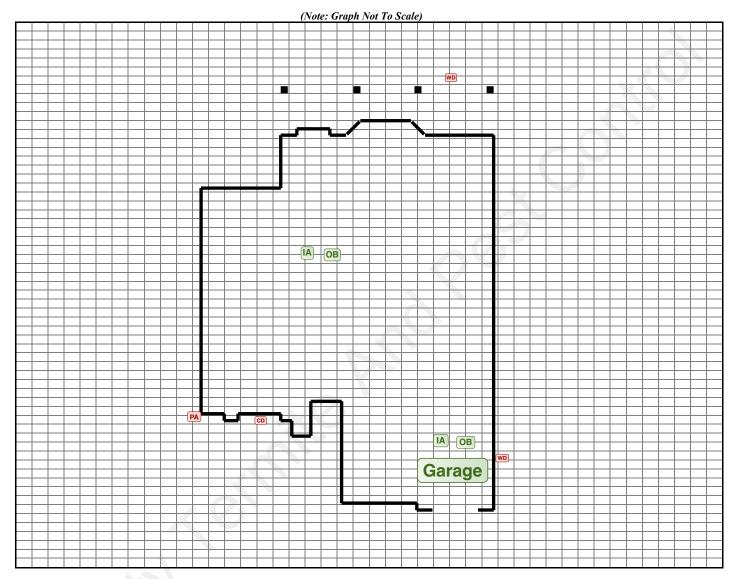
GRAPH OF STRUCTURE(S)

Cellulose debris

Plants abutting structure

Water damage exterior garage door frame

Water damage back porch fascia
